# COUNTY LINE INSPECTIONS

## RESIDENTIAL INSPECTION

2300 Rae Dell Ave  
Austin, TX 78704

# PROPERTY INSPECTION REPORT FORM

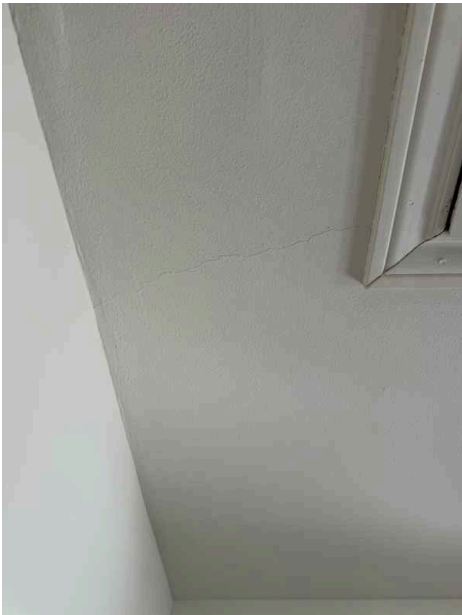
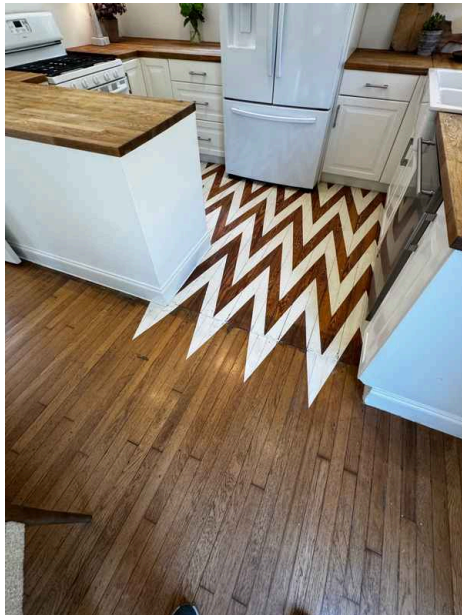
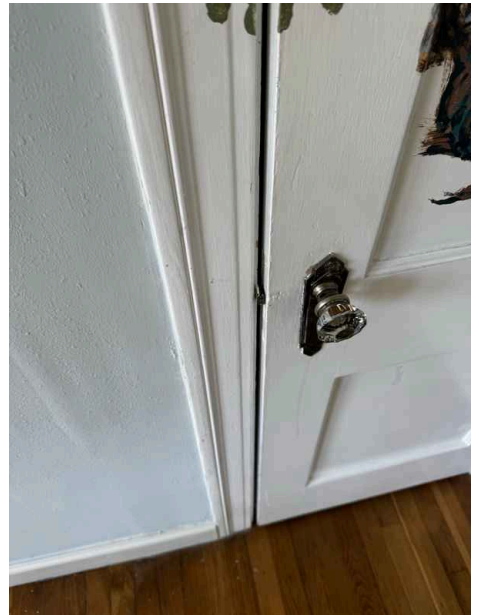
Lateral cracking

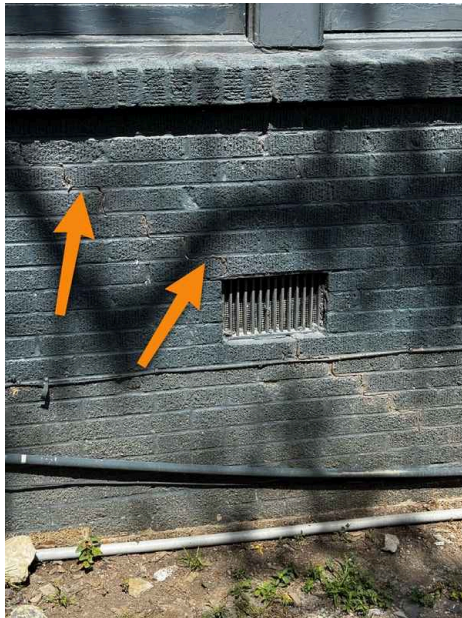
Step fractures still present

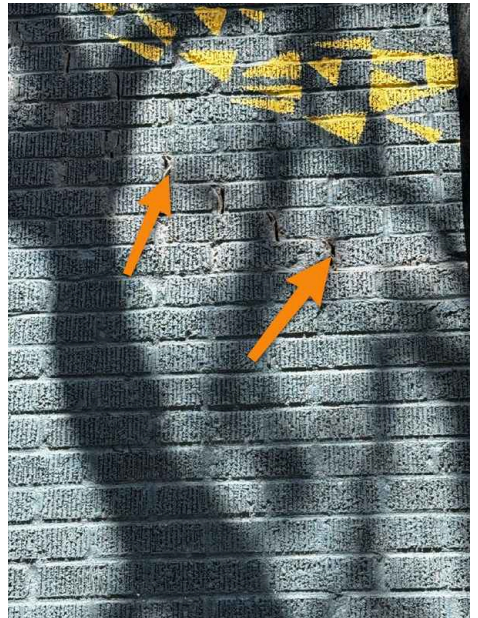
Step fractures still present

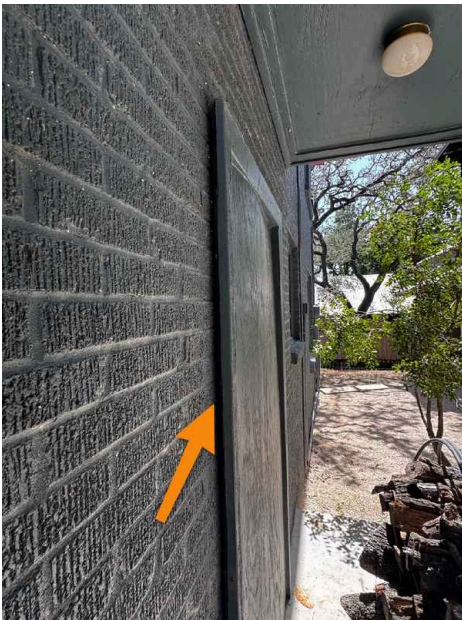
Improper sealing at backside

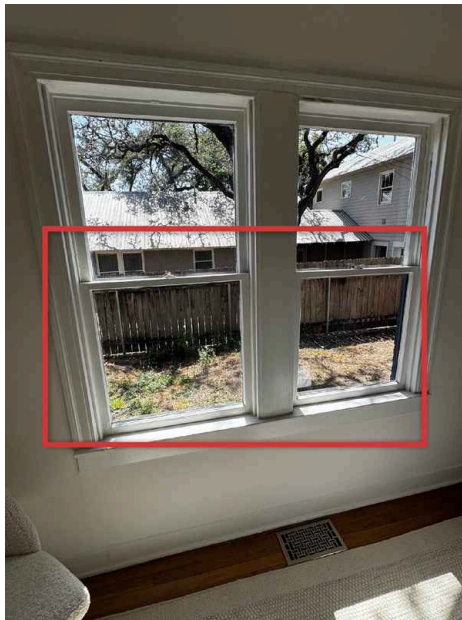
Painted shut bedroom windows still present

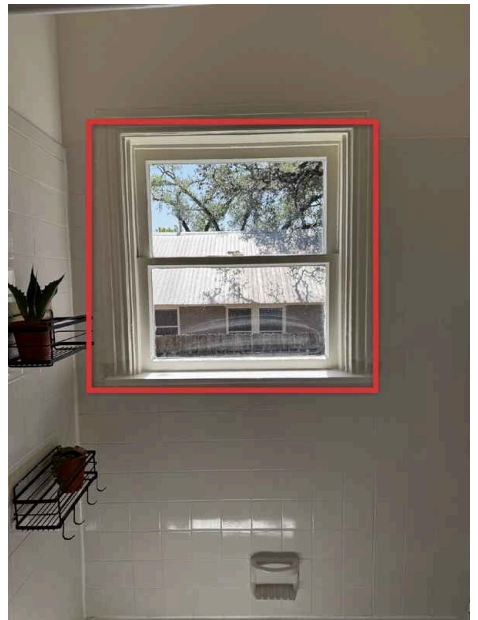
Missing safety glass bath

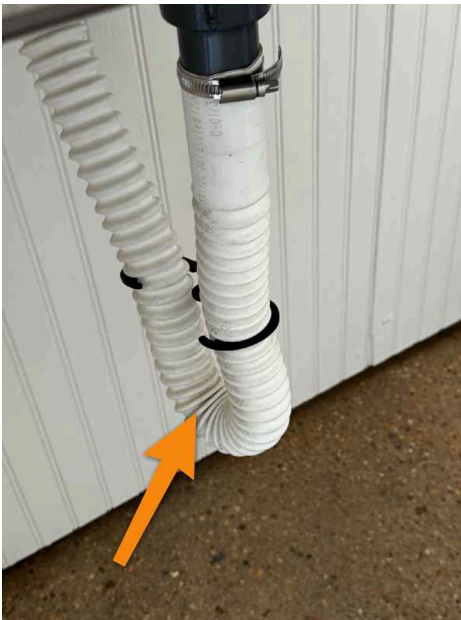
Missing P Trap exterior bath

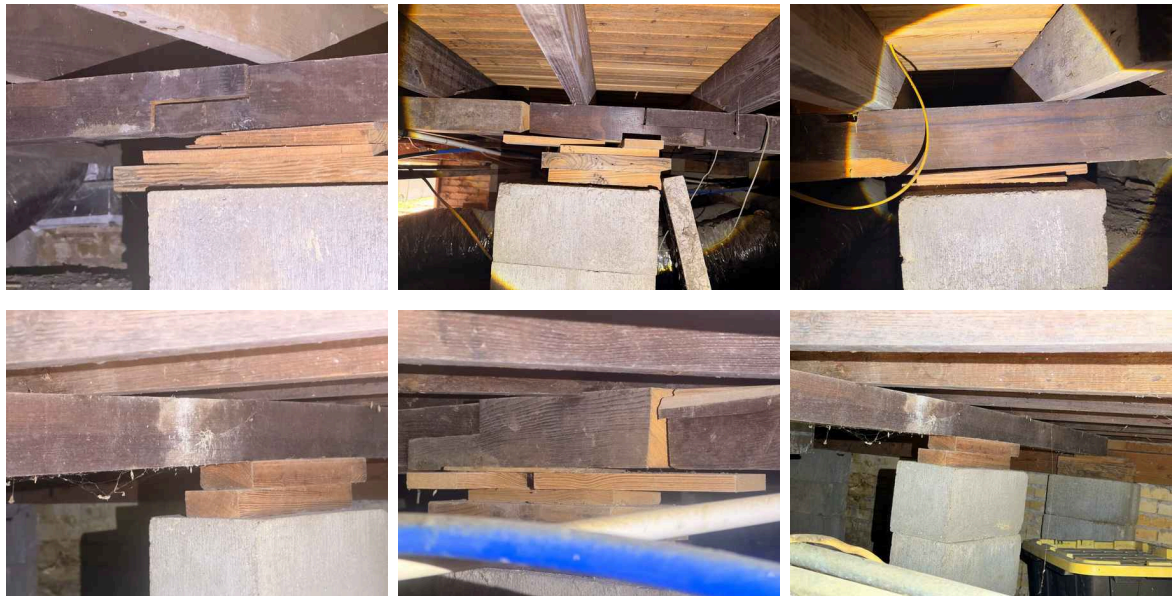
### 1: Improper Shims

Wooden shims cannot hold the proper weight of the house and can cause the piers not to be properly sound. Inspector recommends having the shims replaced with steel or concrete.

Recommendation: Contact a foundation contractor.

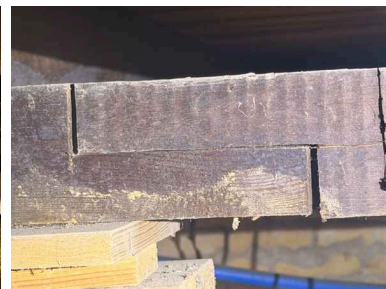
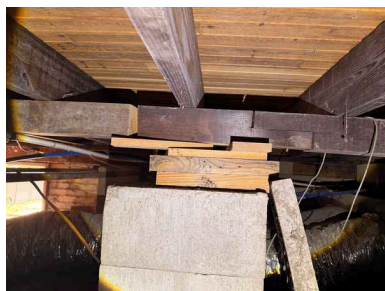
### 3: Improper Splice Support

One or more girders supporting the pier and beam foundation contained butt joints that were not properly supported. Current building standards require girder splices and butt joints to be fully supported by a pier or post. Inspector recommends evaluation and repair by a qualified foundation contractor to ensure the girders are properly supported.

Recommendation: Contact a qualified structural engineer.

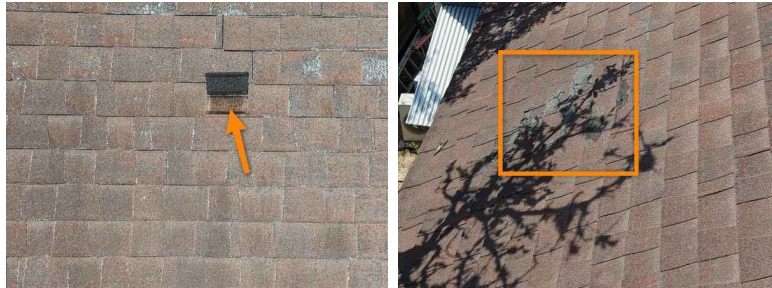
There is one or more roofing coverings that are damaged and could potentially lead to water intrusion. Inspector recommends further evaluation and repair by a roofing professional.

Recommendation: Contact a qualified roofing professional.

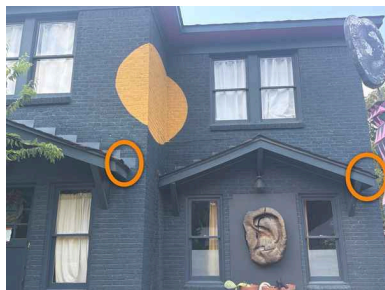
**2: Kickout flashing****➡Recommendation**

There is missing kickout flashing or the kickout flashing that is installed is ineffective in one or more areas of the roof where the roof covering materials contact the siding materials. Properly installed kickout flashing is required to direct roof runoff away from the wall assembly and prevent deterioration to the siding materials and wall structure. A qualified contractor should install or repair the flashing as needed for proper drainage. Per IRC R903.2.1 and R903.2.2, flashing must be installed in a manner that prevents moisture entry into the wall or roof through joints, penetrations, or intersections, and kickout flashing is required at the lower end of roof-wall intersections to direct water away from the wall and into the gutter.

Recommendation: Contact a qualified roofing professional.

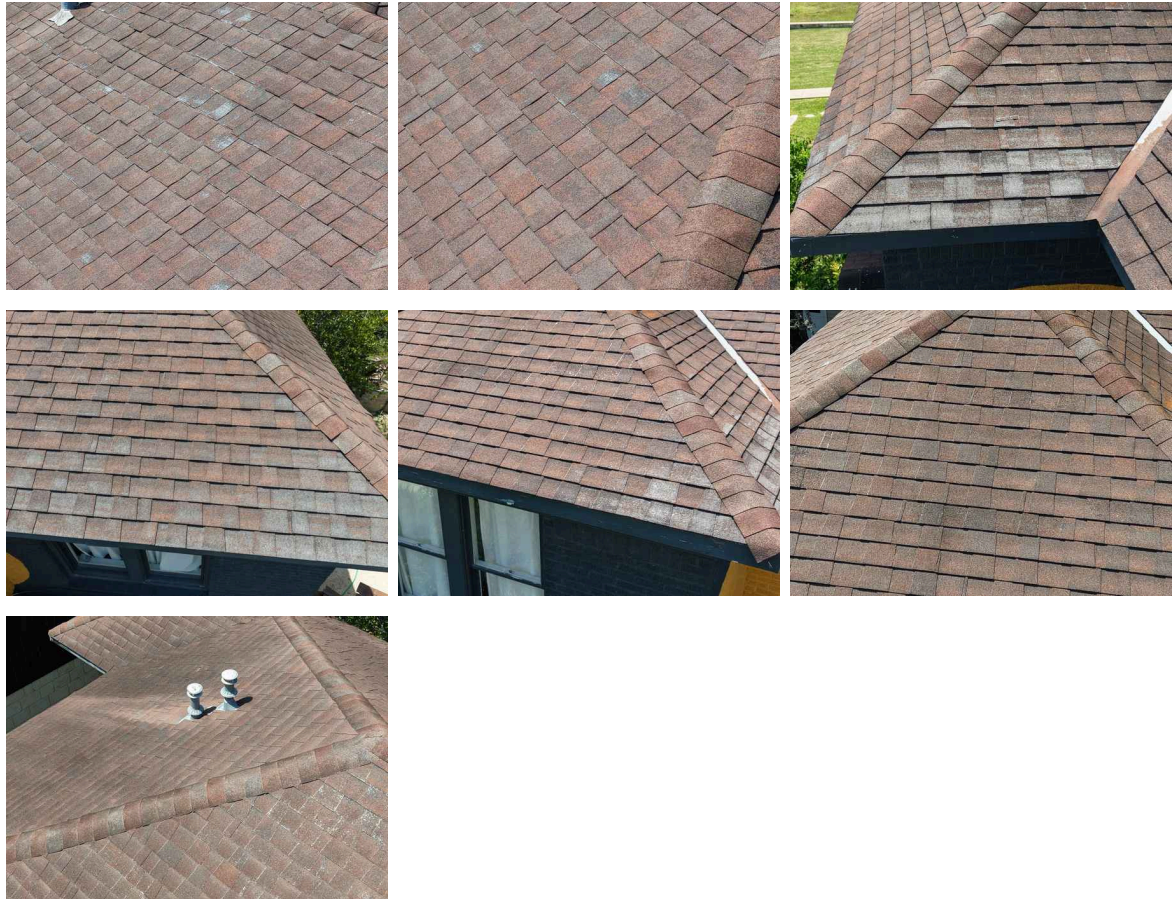
**3: Significant Granular Loss****➡Recommendation**

Apparent and significant wear was noted to one or more sections of the roof covering. These conditions may reduce the expected service life of the roofing material and increase the potential for water intrusion. Inspector recommends further evaluation and any needed repairs or replacement by a qualified roofing contractor.

Recommendation: Contact a qualified roofing professional.

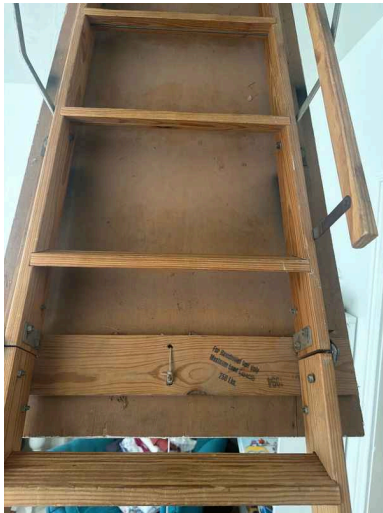
There is no insulation or weatherstripping on the attic access located inside the home as required by current standards. Inspector recommend repair. This can allow for large amounts of energy loss into the home.

Recommendation: Contact a handyman or DIY project

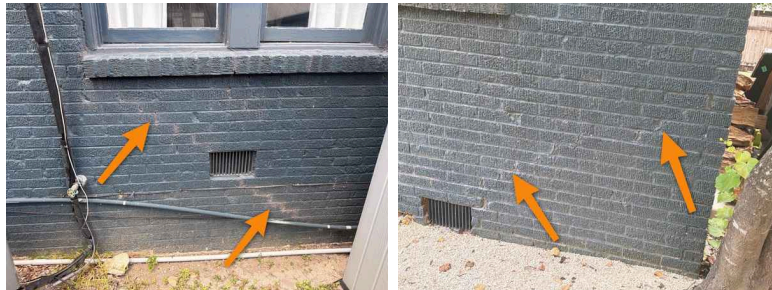
North

There is a large stair step cracks were noted on one or more sides of the stone/brick facade. When the cracks are larger than 1/8" it's indication of foundation movement or significant shifting noted. Inspector recommends having a foundation specialist evaluate if the amount of deflection in the foundation is within acceptable tolerances.

Recommendation: Contact a foundation contractor.

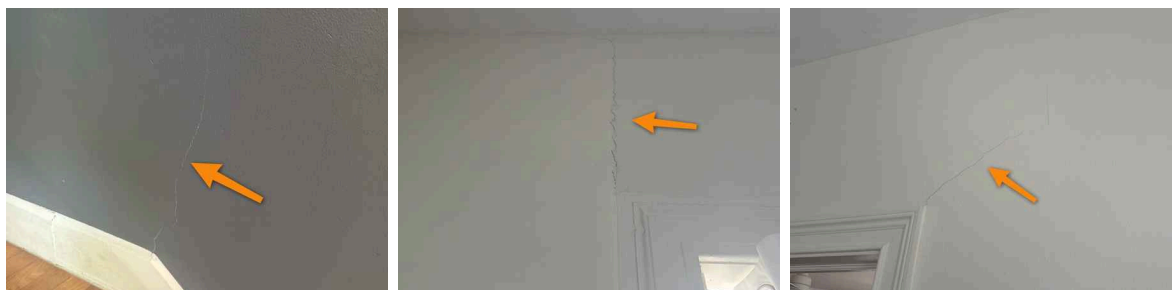
Lateral fractures were observed in the drywall. These types of cracks may be indicative of structural movement and could be associated with foundation settlement, broken or fractured framing components (such as trusses or ceiling joists), insufficient structural support, or improper construction techniques. Further evaluation by a qualified structural professional is recommended to determine the cause and necessary corrective action.

Recommendation: Contact a foundation contractor.

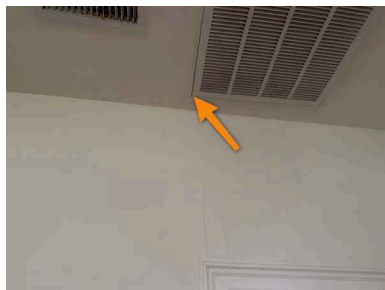
Lateral fractures noted in the ceiling drywall. Lateral fractures often mean there is possible foundation movement. Inspector recommends having the foundation further evaluated. See pictures and locations of drywall that has lateral fractures.

Recommendation: Contact a foundation contractor.

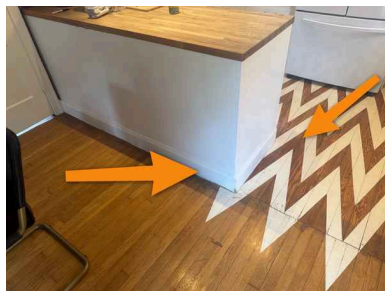
**2: Pier and Beam- slanted**

The home is slanted and uneven in one or more areas of the home. This can be fairly common with pier and beam homes. As your home settles into the soil, the piers holding it up can sink unevenly and shift, causing your floors to sag and be uneven. Inspector recommends having the foundation further evaluated by a foundation specialist.

Recommendation: Contact a foundation contractor.

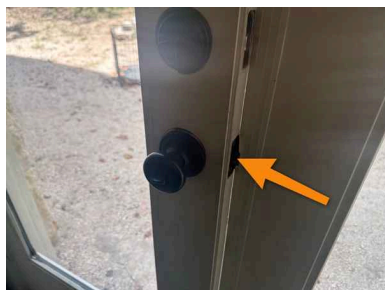
Studio

One or more doors throughout the home were observed to be out of alignment. Conditions included doors that rub against the frame, do not latch properly, or appear off-center. These issues may result from foundation movement, hinge loosening, or frame warping. Inspector recommends adjustment or repair to ensure proper operation. Refer to provided photos and noted locations for specific locations.

Recommendation: Contact a qualified door repair/installation contractor.

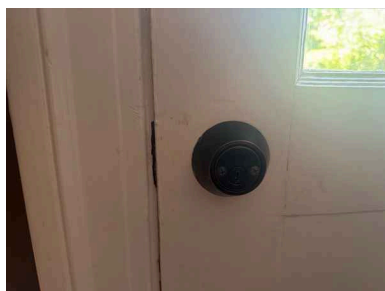
One or more doors around the house contain keyed deadbolts. This is considered a fire safety hazard and any keyed deadbolts should be replaced with a deadbolt which operate on the interior with a thumb turn.

Recommendation: Contact a qualified door repair/installation contractor.

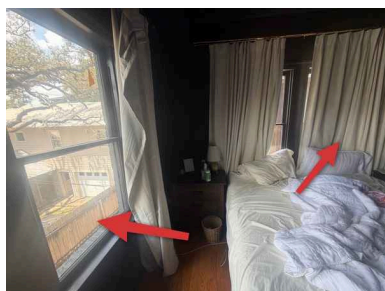
West Bedroom

One or more windows around the house has been painted shut. Inspector recommends of these windows be repaired to normal working condition to comply with current fire egress standards.

Recommendation: Contact a qualified professional.

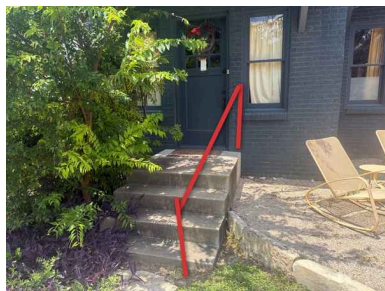
A handrail is required when there are 4 or more risers or if more than 30 off the ground". One or more of the stairs is missing a handrails. This is a safety hazard and one should be installed.

Recommendation: Contact a qualified general contractor.

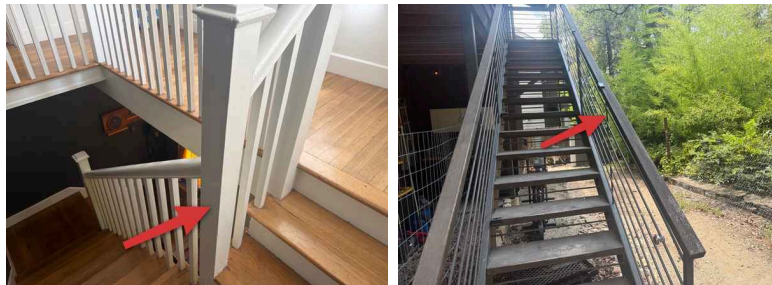
The handrails for the stairs located in one or more areas of the home are loose and considered a safety hazard. Inspector recommends repair.

Recommendation: Contact a qualified general contractor.

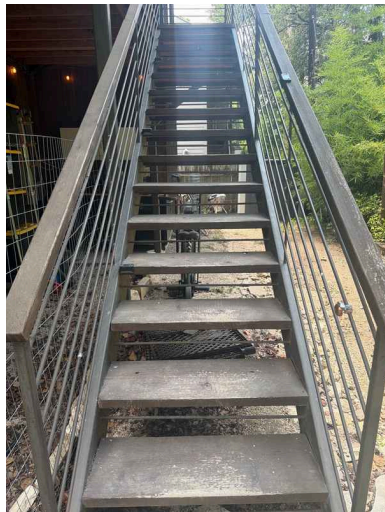
**3: Open Stair Risers****▲Safety Hazard**

The stair risers are open and exceed the maximum allowable opening of 4 inches. Current safety standards require that open risers on residential stairs be constructed so that a 4-inch sphere cannot pass through. This condition presents a potential fall risk, particularly for children. Inspector recommends modifications be made to bring the stair risers into compliance with current safety standards.

Recommendation: Contact a qualified professional.

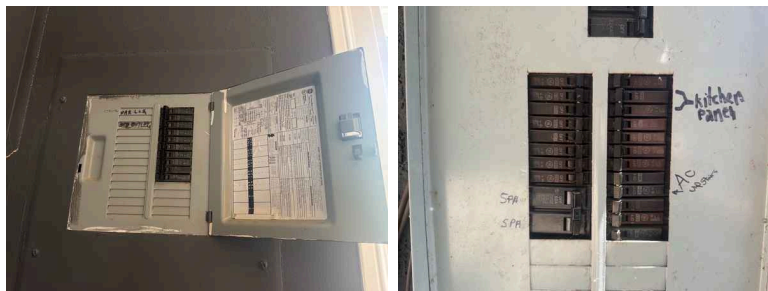
Main Panel

One or more of the electrical panels is not fully labeled or labels are ineligible. This is required by current standards. Inspector recommends repair.

Recommendation: Contact a qualified electrical contractor.

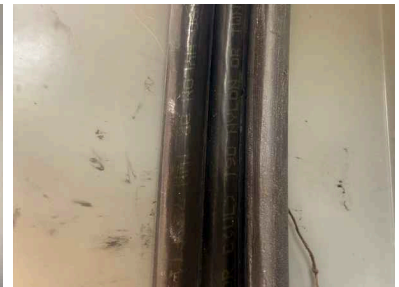
The electrical panel is supplied by 1 AWG copper conductors that are protected by a 200 amp breaker. Based on current standards, 1 AWG copper conductors are undersized for 200 amp overcurrent protection. A typical 200 amp service requires a minimum of 2/0 AWG copper (or 4/0 AWG aluminum) conductors, unless specifically engineered and listed otherwise. This condition may allow the conductors to overheat under load and presents a potential fire and safety hazard. A qualified electrician should evaluate the installation and replace the conductors or provide properly sized overcurrent protection as needed.

Recommendation: Contact a qualified electrical contractor.

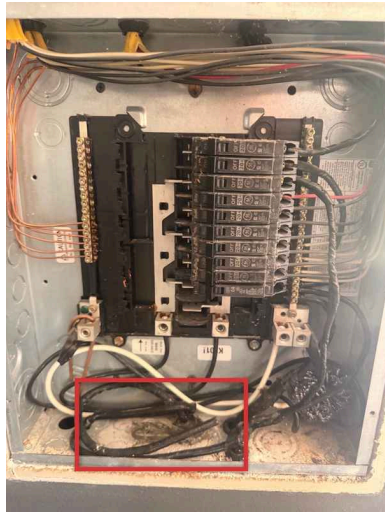
Sub Panel

Unused electrical wiring was observed within the electrical panel. For safety, all inactive conductors should be properly terminated and capped with approved wire connectors to prevent accidental contact or energization. Inspector recommends evaluation and correction by a licensed electrician.

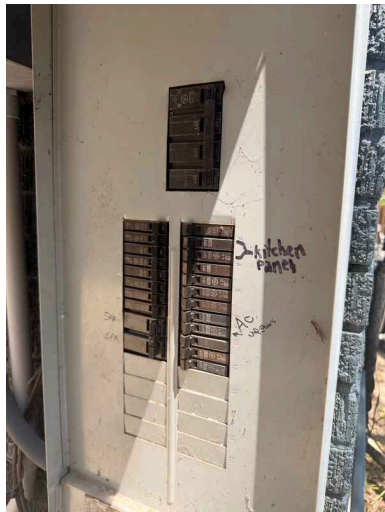
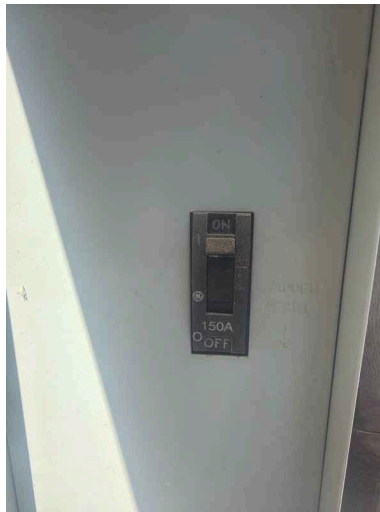
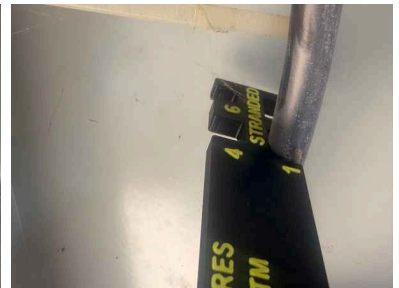
The main electrical panel is equipped with a 200 amp main breaker; however, the upstream service disconnect is rated at 150 amps, and the service entrance conductors appear to be 1 AWG copper, which is typically sized for a 150 amp service. This discrepancy may create confusion regarding the home's actual service capacity. Inspector recommends evaluation by a qualified electrician to verify the installation is properly configured and to make any necessary corrections.

Recommendation: Contact a qualified electrical contractor.

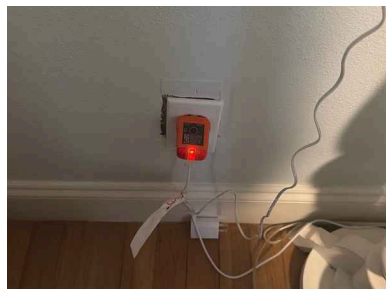
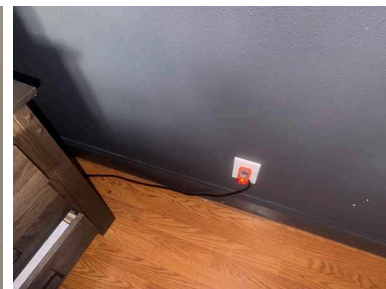
One or more electrical outlets were observed to have open grounds, meaning they are not properly connected to the electrical grounding system. This condition can pose safety risks, including increased shock hazard and interference with certain devices that require proper grounding to function safely. It is recommended that a licensed electrician evaluate and correct this condition to ensure compliance with current electrical safety standards.

Recommendation: Contact a qualified electrical contractor.

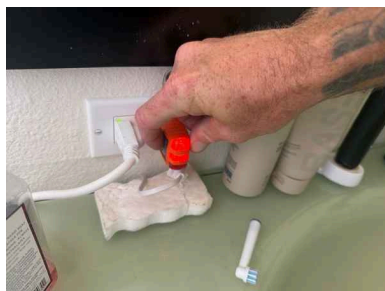
Upstairs Bathroom

One or more GFCI outlets would not pop (work properly). In terms of installation and connection, GFCI outlets can be wired in two ways: the first way is to connect the GFCI outlet at the beginning of the circuit, which provides protection for all the outlets downstream in the circuit. The second way is to connect the GFCI outlet at the end of the circuit, which only protects that specific outlet. If an outlet is installed at the beginning of the circuit and does not pop, then the other outlets do not pop either. Inspector recommends having the GFCI outlets replaced.

Recommendation: Contact a qualified electrical contractor.

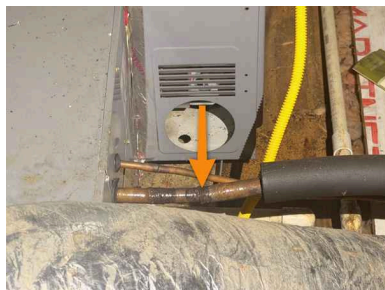
The low-pressure refrigerant line entering the air handler should be properly insulated to prevent condensation from forming and dripping into the drain pan. When insulation is missing or deteriorated, the cold refrigerant line can condense moisture from the warm attic air, leading to potential water issues. The inspector recommends insulating all exposed sections of the refrigerant line to prevent this issue. No copper should be visible, as the copper portion of the line is the coldest and most prone to condensation. Proper insulation will help maintain system efficiency and prevent moisture-related damage.

Recommendation: Contact a qualified HVAC professional.

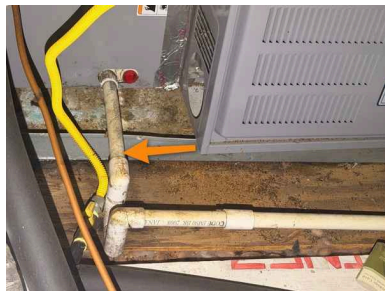
The primary condensation line coming from the air handler should be insulated or better insulated (a minimum of 3' is recommended). This will help prevent excess moisture around the air handler. With moisture there is a chance of black unknown substance.

Recommendation: Contact a handyman or DIY project

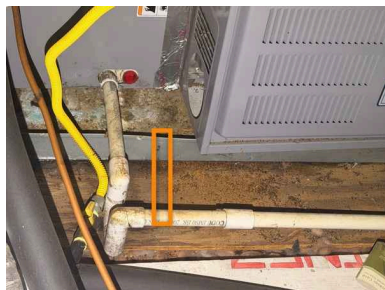
No accessible means for cleaning was observed on the primary condensate drain line. Current standards (IRC M1411.3) require condensate drains to be installed in a manner that allows for cleaning. The absence of a service opening can restrict maintenance, increasing the risk of blockage and potential water damage. Inspector recommends evaluation and correction by a qualified HVAC technician.

Recommendation: Contact a qualified HVAC professional.
