# COUNTY LINE INSPECTIONS

## RESIDENTIAL INSPECTION

2300 Rae Dell Ave  
Austin, TX 78704

# PROPERTY INSPECTION REPORT FORM

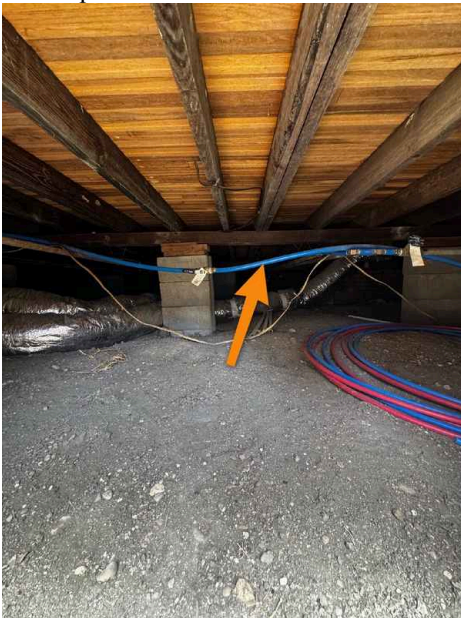
Non insulated supply lines

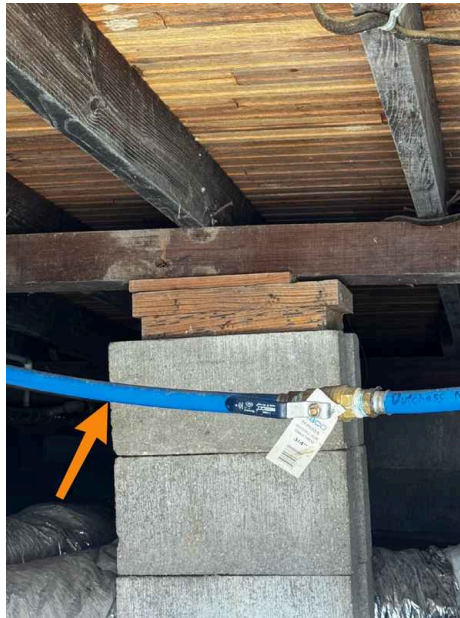
Supply lines not insulated

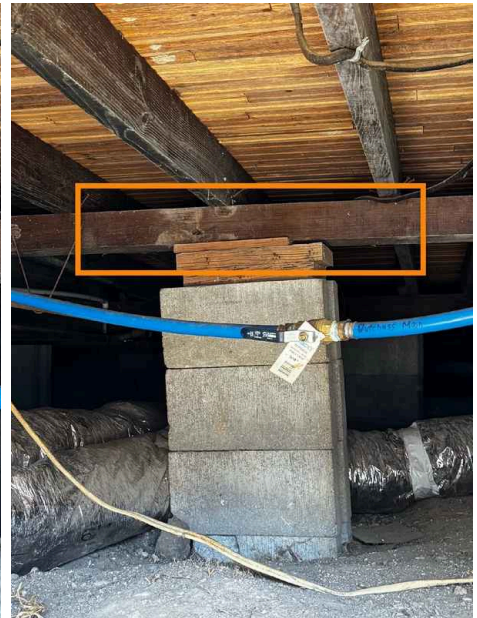
Undersized beam

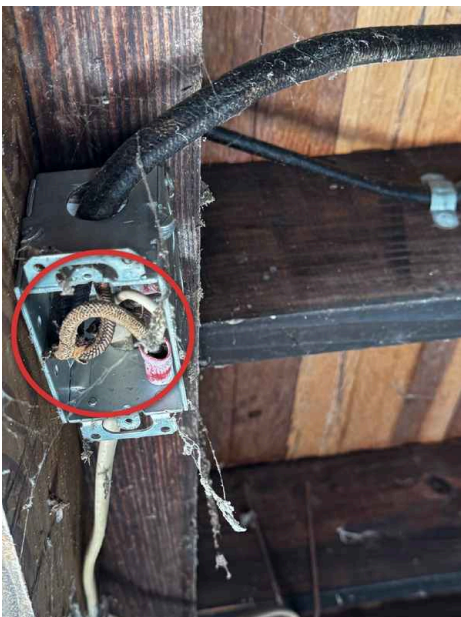
Cloth covered wiring still present

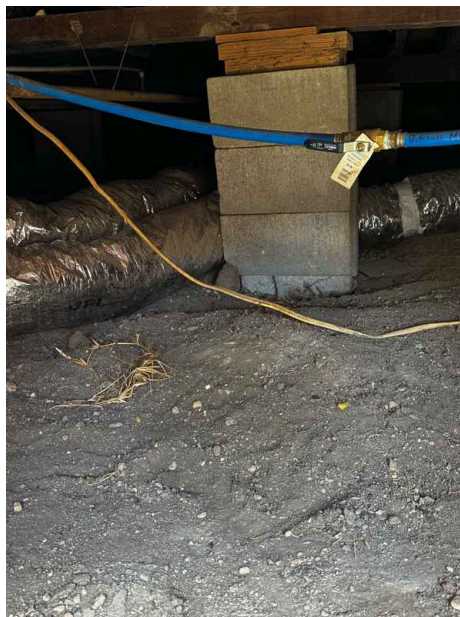
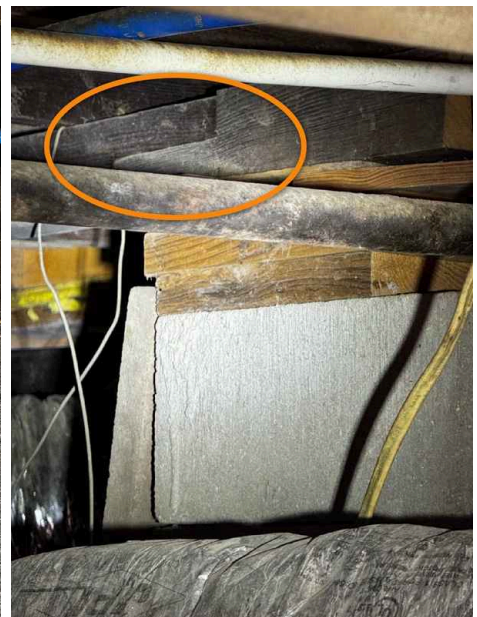
Improper beam connection

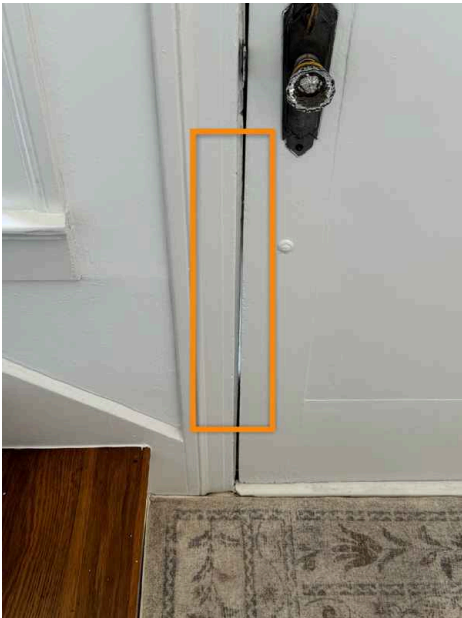
Light and air

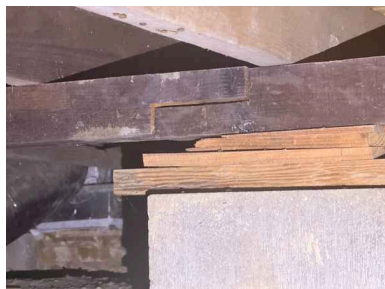
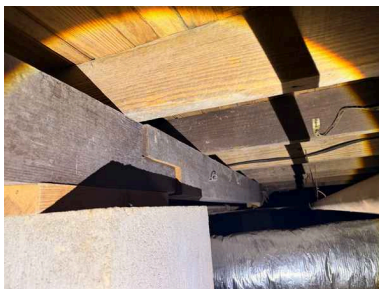
### 3: Improper Splice Support

One or more girders supporting the pier and beam foundation contained butt joints that were not properly supported. Current building standards require girder splices and butt joints to be fully supported by a pier or post. Inspector recommends evaluation and repair by a qualified foundation contractor to ensure the girders are properly supported.

Recommendation: Contact a qualified structural engineer.

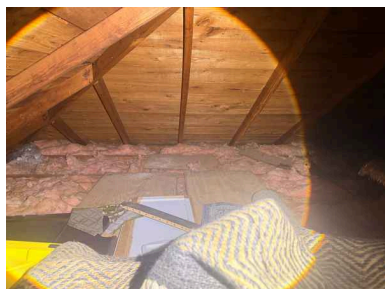
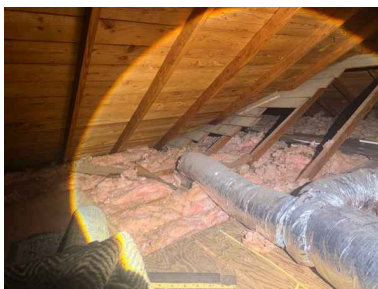
Insulation depth was inadequate. Current standards require a R38 value (12" minimum). Recommend a qualified attic insulation contractor install additional insulation.

Recommendation: Contact a qualified insulation contractor.

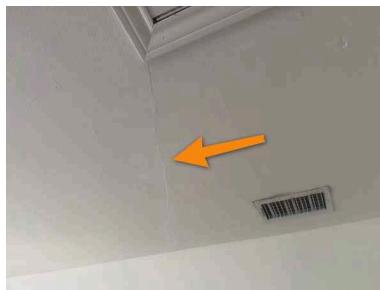
Lateral fractures noted in the ceiling drywall. Lateral fractures often mean there is possible foundation movement. Inspector recommends having the foundation further evaluated. See pictures and locations of drywall that has lateral fractures.

Recommendation: Contact a foundation contractor.

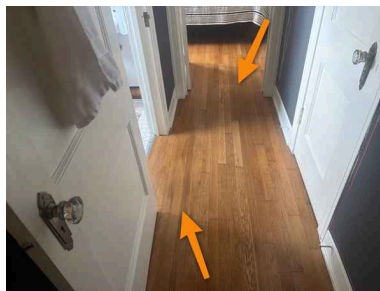
**2: Pier and Beam- slanted**

The home is slanted and uneven in one or more areas of the home. This can be fairly common with pier and beam homes. As your home settles into the soil, the piers holding it up can sink unevenly and shift, causing your floors to sag and be uneven. Inspector recommends having the foundation further evaluated by a foundation specialist.

Recommendation: Contact a foundation contractor.

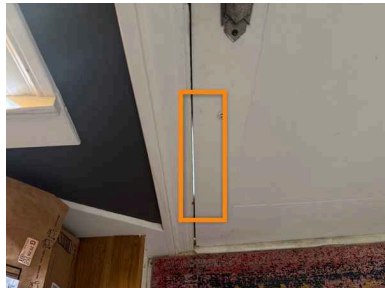
Front Door

Light and air are entering through one or more of the doors. Inspector recommends adjustment of the door latch and weatherstripping to prevent air transfer from the inside of the home to the outside and vice versa. See pictures and locations of doors that have light and air showing.

Recommendation: Contact a qualified door repair/installation contractor.

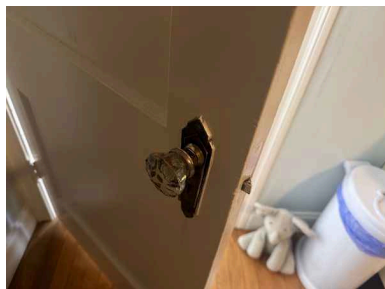
Southwest Bedroom

**4: Knobs- Not working properly****➡Recommendation**

One or more of the door knobs or door knob components are not functioning properly. See pictures with locations.

Recommendation: Contact a qualified door repair/installation contractor.

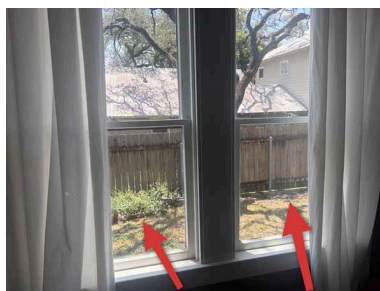
West Bedroom

**2: Painted Shut****▲Safety Hazard**

One or more windows around the house has been painted shut. Inspector recommends of these windows be repaired to normal working condition to comply with current fire egress standards.

Recommendation: Contact a qualified professional.

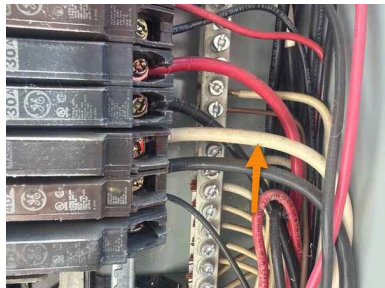
**3: White wires****➡Recommendation**

White (neutral) conductors observed connected to circuit breakers in the panel should be properly re-identified to indicate they are being used as ungrounded (hot) conductors. According to current National Electrical Code (NEC) standards [NEC 200.7(C)], white or gray wires used as hot conductors must be permanently re-identified—typically with colored tape, paint, or labeling (commonly red or black). These conductors were not re-identified as required, which can lead to confusion or potential safety hazards. A qualified electrician should correct this condition.

Recommendation: Contact a qualified electrical contractor.

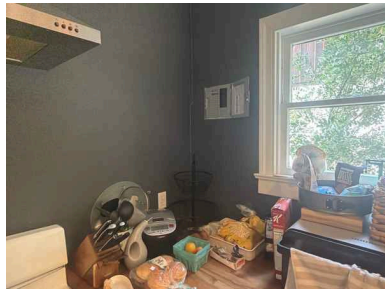
**5: Sufficient workspace****🔴Recommendation**

Sufficient workspace is not present in front and or sides of the electrical panel. A minimum of 3' in front and 30" total on the sides is required by current standards.

Recommendation: Contact a qualified professional.

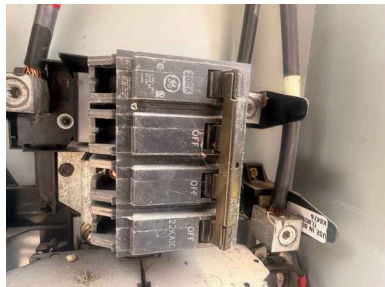
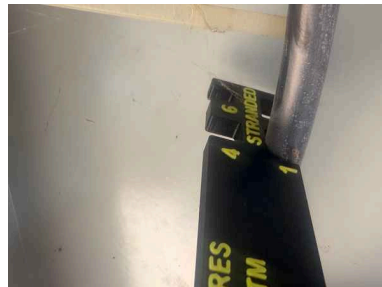
**6: Undersized Service AWG****🔴Safety Hazard**

The electrical panel is supplied by 1 AWG copper conductors that are protected by a 200 amp breaker. Based on current standards, 1 AWG copper conductors are undersized for 200 amp overcurrent protection. A typical 200 amp service requires a minimum of 2/0 AWG copper (or 4/0 AWG aluminum) conductors, unless specifically engineered and listed otherwise. This condition may allow the conductors to overheat under load and presents a potential fire and safety hazard. A qualified electrician should evaluate the installation and replace the conductors or provide properly sized overcurrent protection as needed.

Recommendation: Contact a qualified electrical contractor.

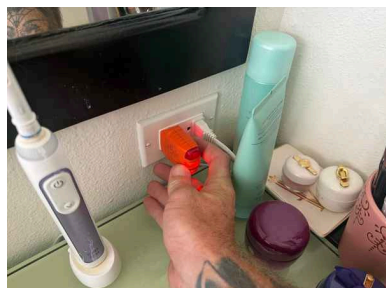
Upstairs Bathroom

Missing GFCI protection in one or more of the bathrooms outlets. This is not allowed by current safety standards and is considered an electrical safety hazard. Inspector recommend repair by licensed electrician.

Recommendation: Contact a qualified electrical contractor.

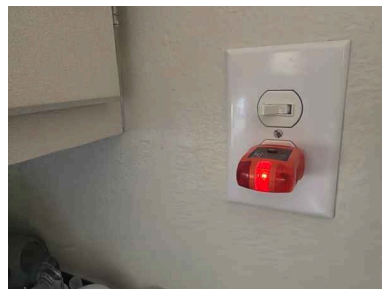
### 3: Open Grounds

One or more electrical outlets were observed to have open grounds, meaning they are not properly connected to the electrical grounding system. This condition can pose safety risks, including increased shock hazard and interference with certain devices that require proper grounding to function safely. It is recommended that a licensed electrician evaluate and correct this condition to ensure compliance with current electrical safety standards.

Recommendation: Contact a qualified electrical contractor.

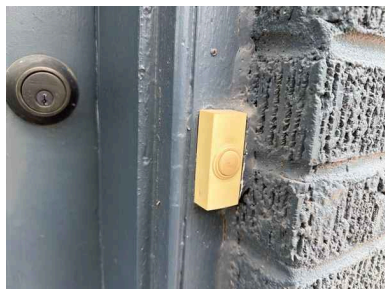
**4: Door Bell- not working****⚠ Safety Hazard**

The door bell was not working properly at the time of the inspection.

Recommendation: Contact a handyman or DIY project

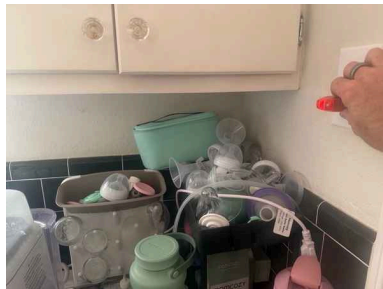
Upstairs Sink

**6: 6'- No GFCi Receptacle****⚠ Safety Hazard**

The receptacle located within 6 feet of the bathroom sink and/or bathtub is not GFCI protected, as required by current safety standards. For enhanced safety and compliance with electrical codes, it is recommended that this outlet be upgraded to a GFCI-protected receptacle.

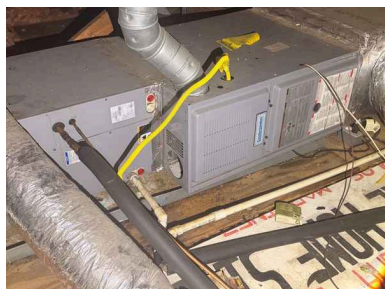
#### 1: Missing Drip Leg

There's no sediment trap (drip leg) on the gas supply line to the furnace as required by current standards. Inspector recommends adding this length of piping to promote a longer life of the furnace burners.

Recommendation: Contact a qualified professional.

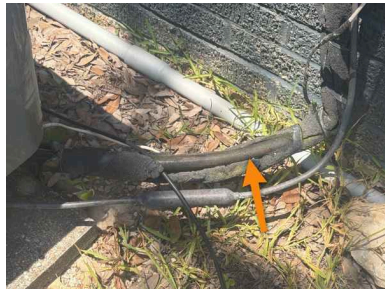
Upstairs

**2: Insulation Missing or Deteriorated****➡Recommendation**

Missing or deteriorated insulation on refrigerant line. This can cause energy loss and condensation. Adding or replacing this insulation can save a significant amount of money.

Recommendation: Contact a qualified HVAC professional.

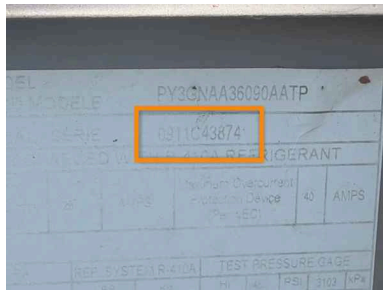
Downstairs RTU

**5: End of life expectancy****Recommendation**

One or more of the air conditioning units (compressors) is 15 years old or older. The typical life expectancy for an A/C unit is approximately 15 years, and this unit appears to be at or near the end of its expected service life. Inspector recommends further evaluation by a licensed HVAC technician to assess current condition and remaining lifespan.

Recommendation: Contact a qualified HVAC professional.

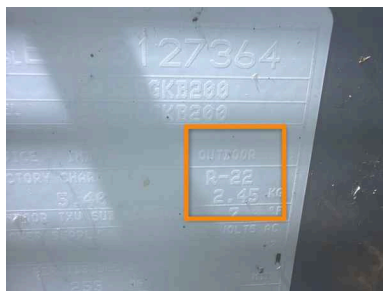
**6: R-22 (HCFC)****Recommendation**

One or more air conditioning systems at the property uses R22 refrigerant. Production and import of new R22 refrigerant in the United States ended on January 1, 2020, which can make future servicing more expensive and more difficult. Continued operation of an existing system is still permitted, but if the system develops a leak or requires major refrigerant related repairs, replacement of the equipment or evaluation for an approved retrofit may be necessary. Recommend budgeting for eventual replacement and consulting a licensed HVAC contractor regarding service options and long term planning.

Recommendation: Contact a qualified HVAC professional.

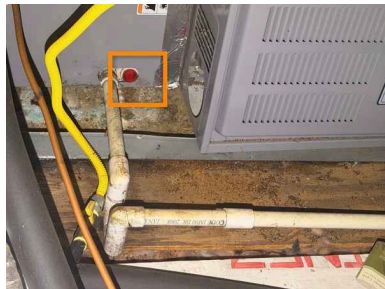
**7: No Secondary****➔Recommendation**

There is no secondary condensate line on the air handling unit. Inspector recommends having an HVAC technician add a secondary line or a float switch to the secondary line to prevent the possibility of water damage to the house in the event of a blockage in the primary condensate line.

Recommendation: Contact a qualified HVAC professional.

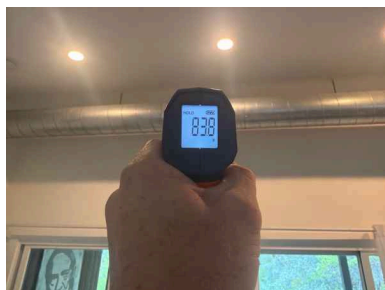
ADU

**10: Mini Split- Not Cooling Properly****Recommendation**

The mini split is not cooling properly. Inspector recommends further evaluation and repair.

Recommendation: Contact a qualified heating and cooling contractor

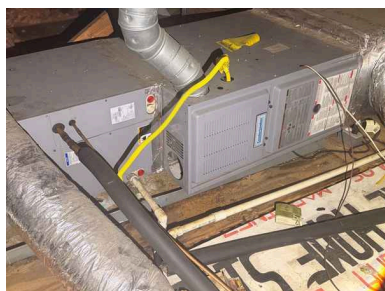
**11: Air Handler- Resting on Pan****Recommendation**

The air handler is resting directly on the auxiliary (emergency) drain pan instead of being properly supported above it. Air handlers should be elevated on approved support rails or brackets to allow the drain pan to function as intended and to help prevent vibration, restricted drainage, and potential damage to the equipment or drain pan. Inspector recommends evaluation and correction by a qualified HVAC contractor.

Recommendation: Contact a qualified heating and cooling contractor

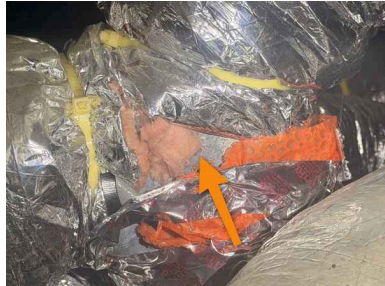
**1: Damaged/Seperated Insulation****➡Recommendation**

There is one or more sections of insulated ductwork that is separated or damaged. Inspector recommends repair to prevent air loss.

Recommendation: Contact a qualified HVAC professional.

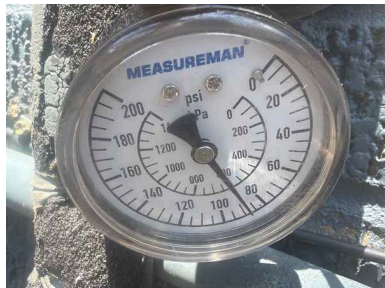
## 2: High Water Pressure

The water pressure was too high according to current standards. The proper water pressure range is 40-80 PSI. This can cause damage to appliances and plumbing supply material. Inspector recommends that a licensed plumber install a pressure reducing valve, if one is already installed then it's recommended adjusting the pressure.

Recommendation: Contact a qualified plumbing contractor.

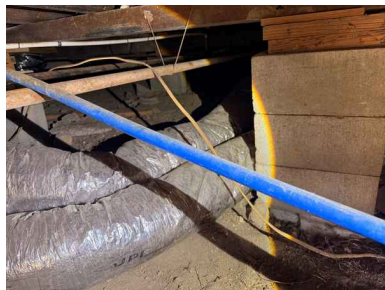
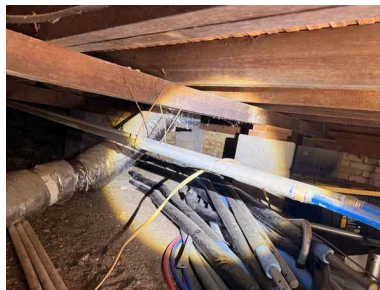
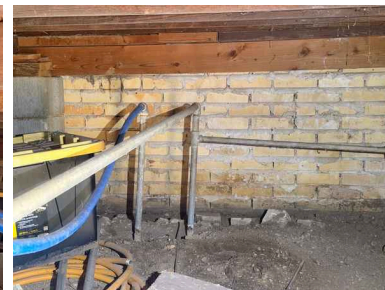
## 3: Water Lines-Not Properly Insulated- Crawl Space

One or more of the water supply lines located under the house are not properly insulated. This can cause broken lines with freezing. Inspector recommends insulated the water lines that are not insulated.

Recommendation: Contact a qualified professional.

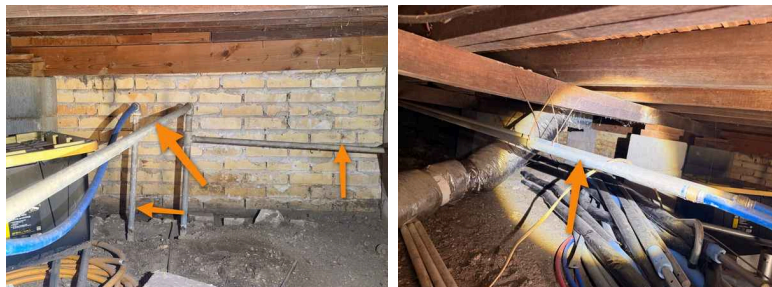
Galvanized water distribution lines were noted under the home. These water lines are well-known for containing blockages which can reduce water flow and water pressure. Typical life expectancy is 40-50 years. Inspector recommends having a licensed plumber conduct a static water test.

Recommendation: Contact a qualified professional.

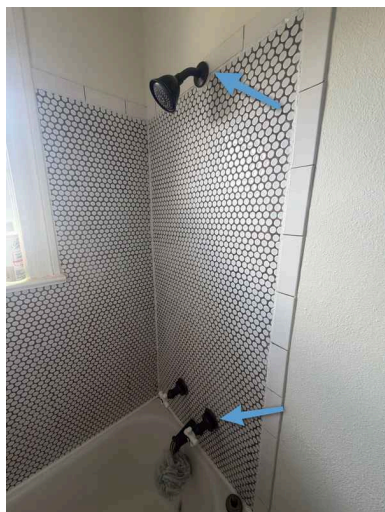
One or more of the tub/shower components (head, arm, faucet, handle, trim) is loose and should be secured properly. Easiest way to secure is often resealing them.

Recommendation: Contact a qualified professional.

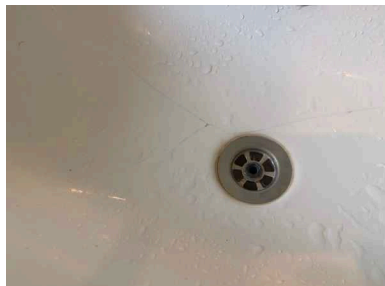
ADU

Cracks and/or damages were observed in one or more of the bathroom sinks. These imperfections may lead to water intrusion, which can cause further deterioration or potential water damage over time. The inspector recommends sealing any cracks or repairing the damaged areas to prevent potential leaks and ensure the longevity of the sink.

Recommendation: Contact a qualified professional.

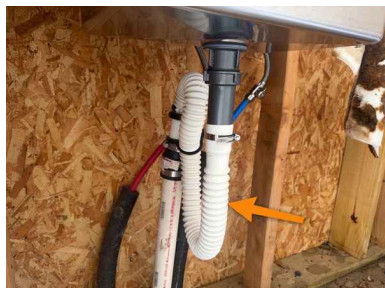
Outside

A flexible drain pipe was observed beneath one or more sinks. These types of fittings are not permitted under current plumbing standards (IRC P3002.3.1) due to their ribbed interior, which can restrict flow and increase the risk of blockages and leaks. Recommend replacement with smooth-walled PVC piping to ensure proper drainage and compliance.

Recommendation: Contact a qualified plumbing contractor.

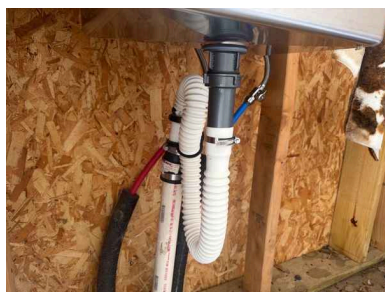
Outside Sink

Improper drainage and/or plumbing configuration was observed under one or more sinks. These conditions may impede proper water flow and increase the risk of leaks or backups. Inspector recommends evaluation and correction by a licensed plumber to ensure proper drainage and compliance with standard plumbing practices.

Recommendation: Contact a qualified plumbing contractor.

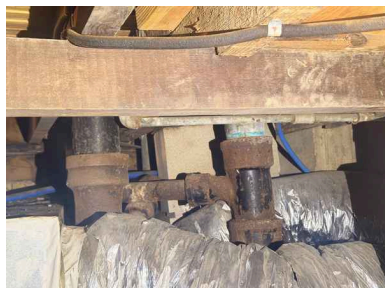
The home is equipped with cast iron drain lines, which were commonly used in older construction but have largely been replaced by PVC in modern building practices due to concerns over corrosion and reduced lifespan. Cast iron may still be functional but can deteriorate internally over time. The inspector recommends that a licensed plumber evaluate the condition of the cast iron piping to determine its current serviceability and whether replacement is warranted.

Recommendation: Contact a qualified plumbing contractor.

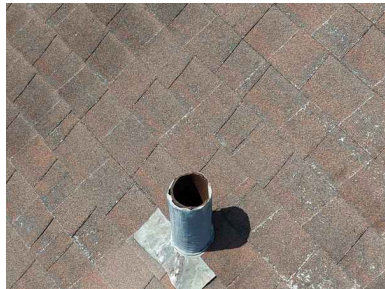
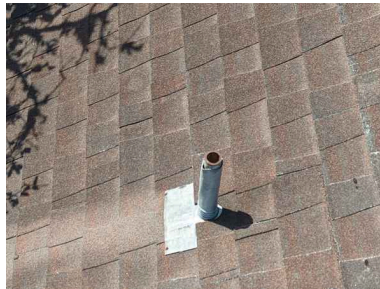
The lead plumbing stack cover located in one or more areas of the roof is deteriorated, or chewed from rodents. This can potentially lead to water intrusion. The cover should bend and go into the actual stack.

Recommendation: Contact a qualified roofing professional.

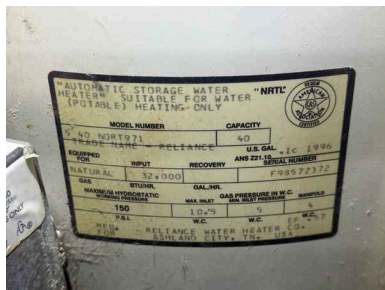
Upstairs

Although currently working properly. One or more of the water heater is nearing the end of it's usable life (typically life expectancy is 15 years). Inspector recommends that a licensed plumber determine the cost of replacement before the option period ends.

Recommendation: Contact a qualified plumbing contractor.

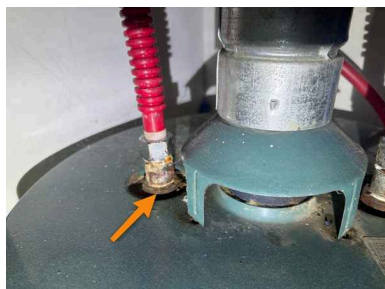
Corrosion was noted on the water supply line. Inspection recommend repair by a licensed plumber to prevent premature deterioration of the steel metal in the water heater.

Recommendation: Contact a qualified professional.

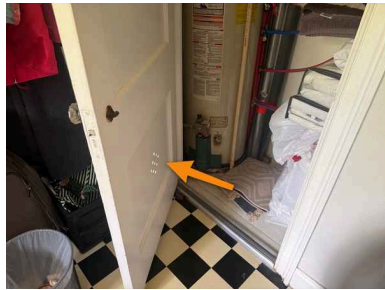
Upstairs Laundry Room

Insufficient venting was noted in the water heater closet. Modern standards require dedicated combustion air ducting to supply fresh air to the appliance rather than relying on conditioned indoor air. Proper installation typically includes openings or ducts that terminate within approximately 12 inches of the ceiling and within 12 inches of the floor to allow adequate air circulation. Inadequate combustion air can affect performance and may create unsafe operating conditions. A qualified contractor should evaluate the installation and make necessary corrections to provide proper combustion air.

Recommendation: Contact a qualified professional.

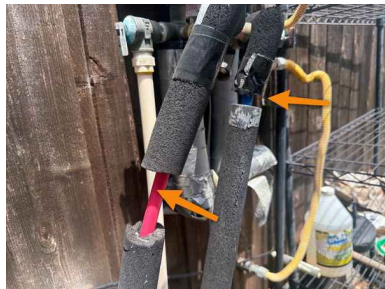
The water lines located next to or around the tankless water heater are not fully insulated. These lines should be insulated to help prevent freezing.

Recommendation: Contact a qualified professional.

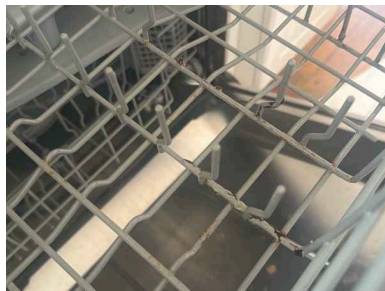
Rust was noted inside the dishwasher on one or more racks. This is considered a health hazard and should be repaired or replaced.

Recommendation: Contact a handyman or DIY project

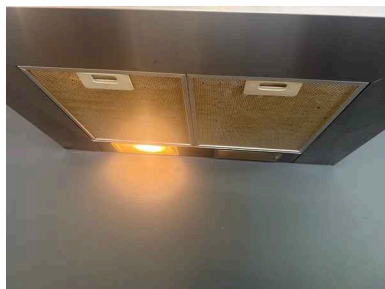
One or more of the lights on the exhaust was not working at the time of the inspection. Replacing the bulb(s) is typically needed.

Recommendation: Recommended DIY Project

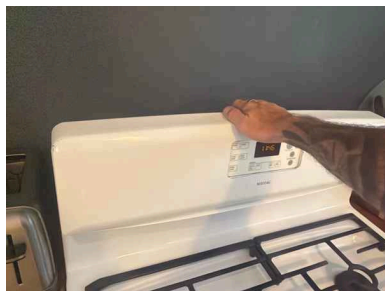
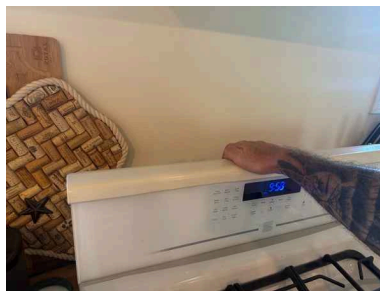
ADU

There is no anti-tip bracket attached to the wall behind the stove. This is considered a safety hazard and should be added. Inspector recommends repair.

Recommendation: Contact a handyman or DIY project

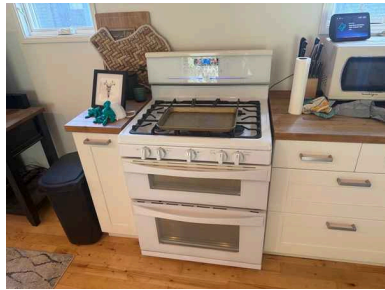
The oven produced a strong natural gas odor when tested. While a brief gas odor during ignition can be normal, a strong or persistent gas odor may indicate improper burner ignition, a gas leak, or another defect. Due to the potential safety hazard, the oven should not be used until it has been evaluated and repaired as needed by a qualified appliance contractor or licensed plumber.

Recommendation: Contact a qualified professional.

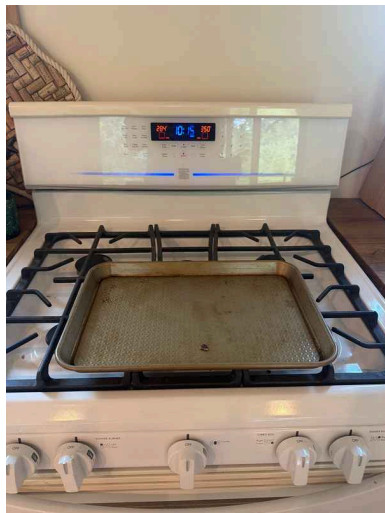
The upper oven required significantly longer than normal to reach the selected temperature. During testing, the lower oven preheated within an expected timeframe, while the upper oven took approximately 10 minutes longer to heat. This condition may indicate a failing bake element, igniter, temperature sensor, control board, or another component affecting proper operation. Inspector recommends further evaluation and any necessary repairs by a qualified appliance repair technician.

Recommendation: Contact a qualified professional.

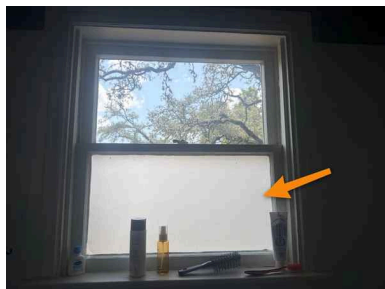
Downstairs Bathroom

The bathroom(s) lacks adequate ventilation, as there is no exhaust fan or operable window present. Proper ventilation is important to control moisture levels, reduce the risk of microbial growth, and maintain air quality. It is recommended to install a vent fan or ensure a window can be opened to meet ventilation requirements.

Recommendation: Contact a qualified professional.
